ES_LPC177x/8x

Errata sheet LPC177x/8x

Rev. 3.3 — 14 February 2013

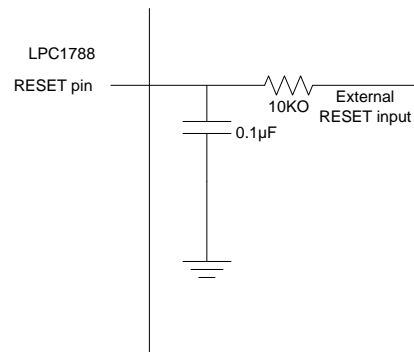
Fig 2. RTC.1 work-around

RTC temporarily pauses and loses fractions of a second during the rising and falling edges of RESET. This occurs only in the LQFP packages with certain voltage swings and ramp rates. The problem is exacerbated by low temperatures. Reducing the voltage swing and/or ramp rate of the reset pulse will eliminate this loss of time counts. When this issue occurs, the impact on RTC accuracy is expected to be one second every several thousand reset events.

Adding an RC filter between the reset pin and the external reset input to control the reset signal voltage ramp rate can prevent this problem.
