# ES\_LPC435x/3x/2x/1x Flash

## Errata sheet LPC435x/3x/2x/1x flash-based devices

Rev. 4 — 22 July 2013

Errata sheet

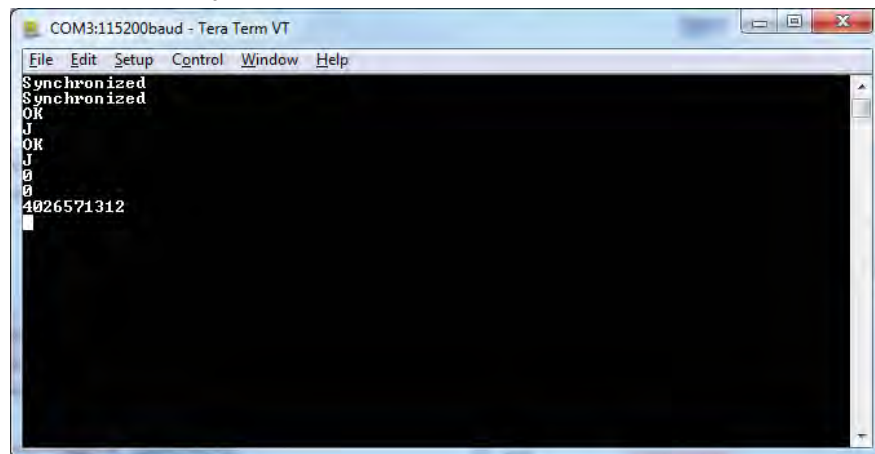
Incorrect example:

The 'J' command in ISP mode should return an error code, followed by an ASCII string representation of the part ID, followed by a 0. However what is actually returned is the error code, followed by a 0, followed by an ASCII string representation of the part ID. The problem is the last two items returned are swapped.

There is no work-around for this problem.

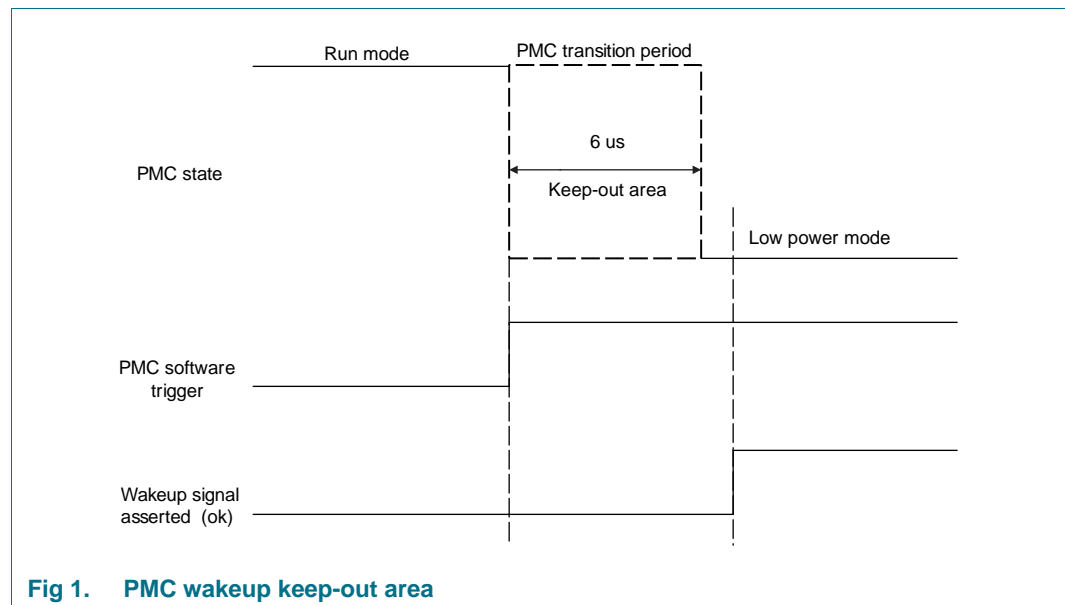
When the chip is in a transition from active to Deep Sleep, Power Down, or Deep Power Down, wakeup events are not captured and they will block further wakeup events from propagating. The time window for this transition is 6  $\mu$ s and is not affected by the chip clock speed. After a wakeup event is received during the PMC transition, the chip can only recover by using an external hardware reset or by cycling power.

Make sure that a wakeup signal is not received during the Deep Sleep, Power Down, or Deep Power Down transition period. An example circuit to work around this could include an external 6  $\mu$ s one shot which could be triggered via software using a GPIO line when entering Deep Sleep, Power Down, or Deep Power Down mode. The one-shot's output could be used to gate the wakeup signal(s) to prevent receiving a wakeup signal during the PMC transition period. Depending on the system design, it may also be needed to latch the wakeup signal(s) so that they will still be present after the one-shot's 6  $\mu$ s timeout.

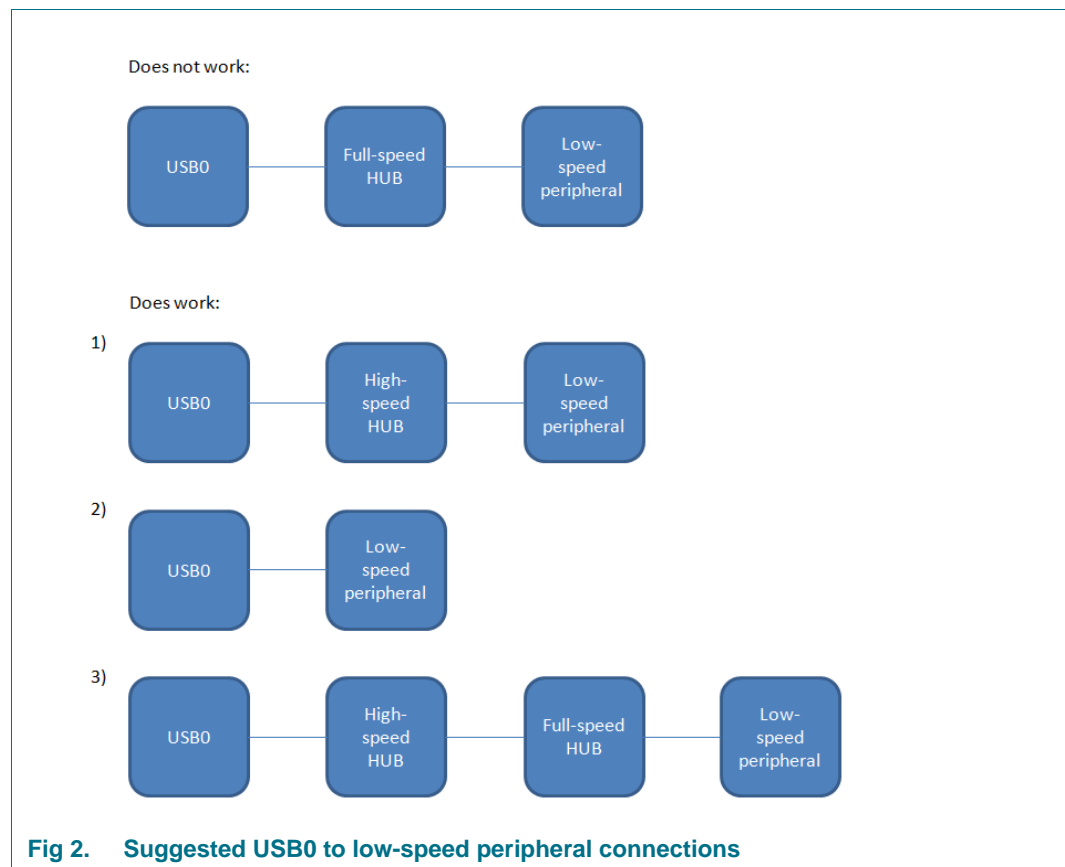
The USB controller called USB0 is unable to communicate with a low-speed USB peripheral in host mode when there is a full-speed hub directly connected to the USB0 port and a low-speed peripheral is connected in the tree somewhere below this full-speed hub. Only USB0 has this problem; the other USB controller, USB1 does not.

There is no work-around for this problem. It is suggested that the low-speed USB peripheral is either connected directly to USB0 or a high-speed hub is placed between that peripheral and USB0.
